# Manhole Inspection Summary

Manhole # S37YY\_043MH

Insp Date: **12/29/06 11:19 AM**

**Location** Address: **642 33RD ST**

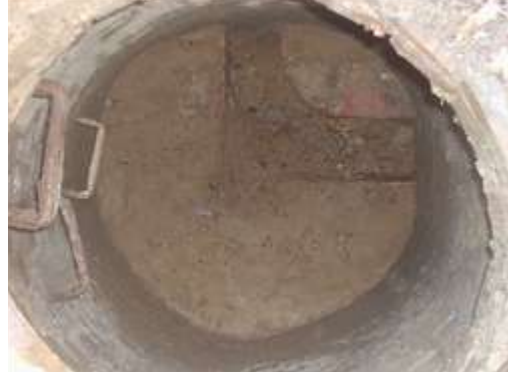
Top View

**Steps** Count: **3** Missing: **0** ☒ **Corroded**

**Surcharge** ☒ **Evidence Of Surcharge** Depth: **1.5** (ft.) ☐ Active Surcharge Present

Corroded steps. Evidence of surcharge - Bench debris. Channel debris.

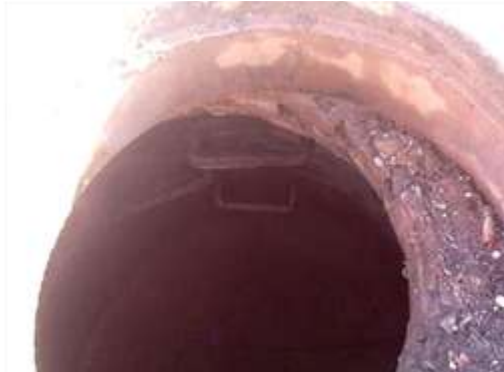
Defect

**Frame** Offset: **6** (in.) Condition: ☐ Sound ☐ Cracked ☒ **Leaks**

Condition: ☐ Sound ☐ Cracked ☐ Root Intrusion ☐ Loose Brick ☒ **Deteriorated**

Infiltration: ☐ None ☒ **Joint** ☐ Cracks ☐ Mortar ☐ Roots ☒ **Wall**

Infiltration: ☐ None ☐ Joint ☐ Cracks ☐ Mortar ☐ Roots ☒ **Wall**

Frame leaks. Frame offset. Adjustment deterioration and infiltration. Barrel infiltration.

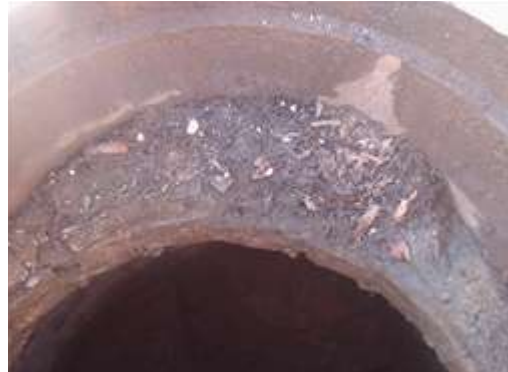
Defect

Frame leaks. Frame offset. Adjustment deterioration and infiltration.

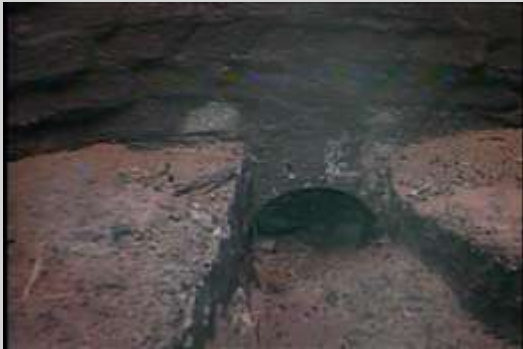
### 8 in. Circular Gravity Sewer Pipe Out @ 12 O'Clock

Deposits: ☐ None ☒ Mud ☐ Gravel ☒ Debris ☐ Grease

Silt Depth: **5** (in.) Deposits Extent: **Heavy**

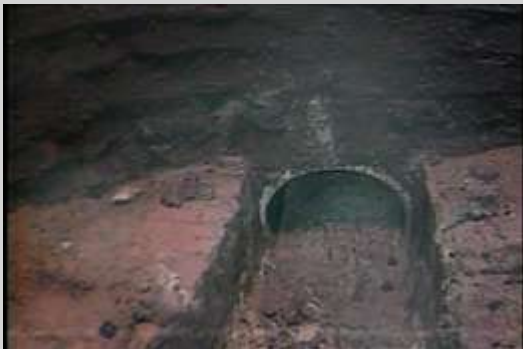
### 8 in. Circular Gravity Sewer Pipe In @ 3 O'Clock

Deposits: ☐ None ☐ Mud ☒ Gravel ☐ Debris ☐ Grease

Silt Depth: **6** (in.) Deposits Extent: **Heavy**
